Camera Distortion on bottom of image

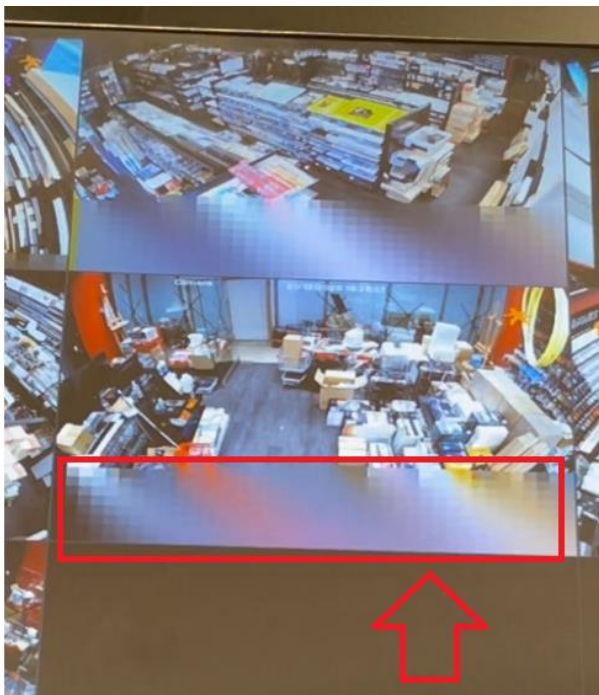
Please refer to image below (highlighted in red).

If you are experiencing similar distortion / artefacts on your cameras:

- Adjust the substream settings of your camera
Recommended substream settings
Resolution: 640 x 480
Bitrate: 512kbps

If the problem continues after modifying substream settings upgrade your camera firmware.
Refer to relevant camera model documentation below
